## CASE STUDY

# AUTOMATIC GATE AT PRIMARY SCHOOL STAFF CAR PARK

**Setting:** Commercial (Education establishment)

**Type of Gate:** Double leaf swing gates constructed of steel box section and tube. Automated with 24-volt ram motors fitted at high level.

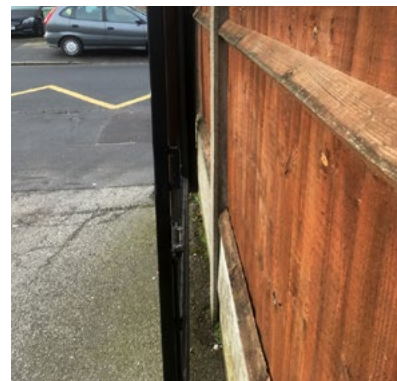
1. Risk of impact, trapping and crushing. Safety edges were only fitted horizontally to the bottom of the gate leaves on the inside of site. When tested, these edges only stopped the gates but did not revert. This represented a potential hazard since there was potential for a person to be pinned and trapped against the fence.

risk of gate crushing against a fence

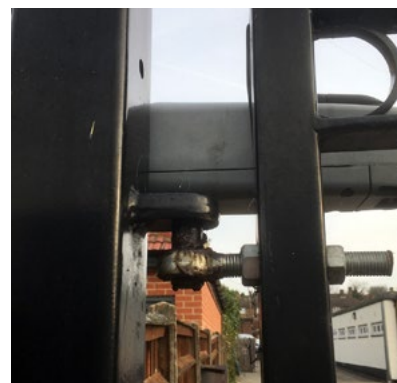
3. Risk of impact and crushing. Only two hinges per leaf were fitted, with the top hinges inverted. In the event of one hinge failing, the leaves could easily fall. The weight of the leaves is supported only by the bottom hinges as the top ones are inverted, resulting in an even greater possibility of a gate failure.

inverted hinge

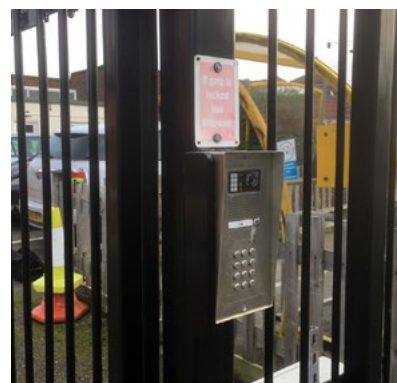
4. Risk of trapping and crushing. Large gaps were identified at hinges (over 100mm) which reduced substantially when the gates were opened. There was no evident sign of protection in this area which is subject to massive forces. The intercom outstation was mounted to the outside on the hang stile and was only reachable from the wrong side of the gates potentially causing someone to be in the most dangerous area.

reducing gap at the hinge

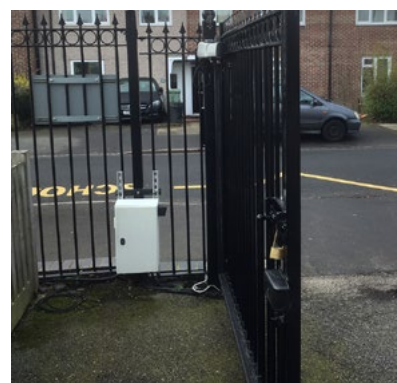
5. Risk of impact and crushing. No inside photocells were fitted to cover the arc of the gates.

gate features no inside photocells
