## CASE STUDY

# DOUBLE LEAF SWING GATES AT UNDERGROUND CAR PARK

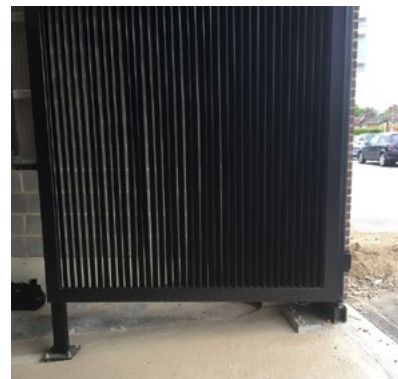
1. Risk of impact and crushing. No safety edges fitted to the gate system. The leaves opened up towards walls on either side and had reducing gaps between the leaves as they close and a further reducing gap due to sloping ground under the leaves as they close. (The motors were also set up with a very large amount of force and could not be easily stopped by hand)
2. Risk of trapping and crushing. Reducing gap at the hinge positions as the gates opened and closed. This was unprotected and had the maximum amount of force at these points.
3. Risk of impact and crushing. Photocells fitted were positioned too far from the moving gate leaves and did not communicate with the system when activated.
4. Risk of crushing. Only two hinges were fitted to these large and heavy gates. If a hinge were to fail, the gates could easily fall, potentially causing serious injury.

no safety edges fitted to prevent crushing

Initially, the installation company could not see any problems with the system. This demonstrates the importance of knowledge and specialist training to ensure the safety of an automated gate system. However, after a few phone conversations the installation company began to appreciate the risks associated with the installation and agreed to undertake the necessary remedial works.

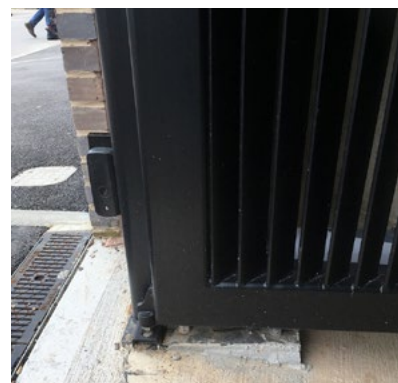
no hinge protection or safety edge where the force is greater nearest the hinge

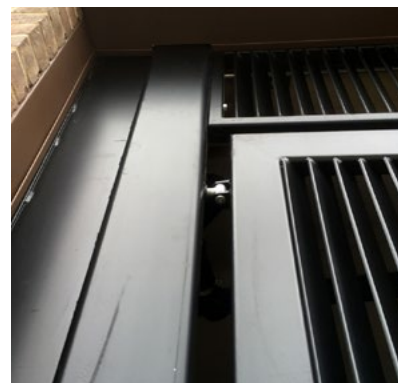
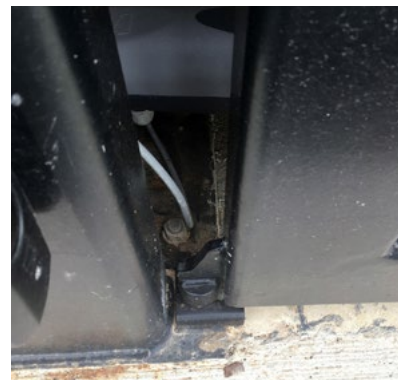
reducing gap and hinge with very high force
