CASE STUDY

SLIDING GATE AT MULTI OCCUPANCY FLATS

Setting: Multi occupancy flats

Type of Gate: Single leaf tracked slider constructed of box section steel and railing powered by a 24 volt operator.

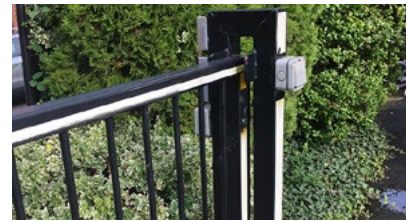
1. Risk of impact and crushing. No physical stop in the closed position. Potentially the gate could move past the fully closed position if the motor lost its position or the gate was moved in manual release.

Risk of impact and crushing

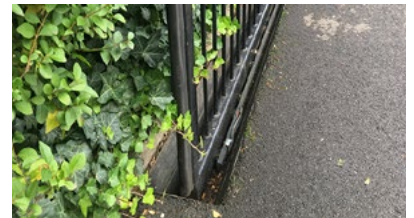
2. Risk of dragging and drawing in. No protection to gate leaf as it runs in the gully. Motor drive is also exposed. Potential access available from the outside of site between the hedge and gate. All these risks could be easily mitigated if the run back area were to be fenced off.

Risk of dragging and drawing in

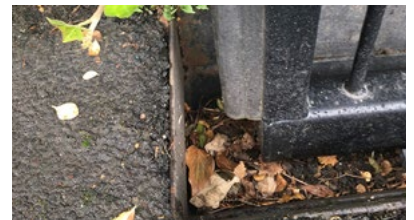
3. Risk of impact and crushing. Safety edge fitted to the rear of the gate leaf 120mm from bottom. This leaves an area unprotected by the edge. NOTE the requirement for this edge will be negated by the fitting of the cage as mentioned above.

Risk of impact and crushing

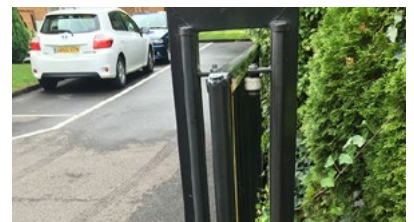
4. Risk of impact and crushing. Safety edges revert the gate when activated irrespective of gate direction. This could trap someone against the close portal if they touched the safety edge on the gate as it was opening. The edges should be wired to only work only in their desired direction.

Risk of impact and crushing

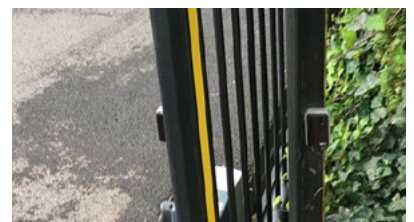
5. Risk of dragging and drawing in. Photocells do not stop the gate from starting to open should the photocell beam be obstructed. A person could place a limb through the gate and be dragged as the gate opens even if the photocells were interrupted.

Risk of dragging and drawing in

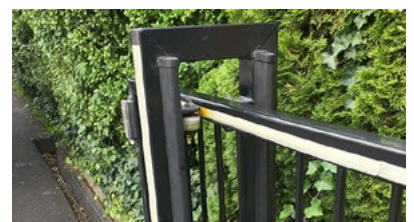
6. Risk of dragging and drawing in. Gap above the gate leaf in the hang portal is very large (100mm). Someone could get dragged into a dangerous position should they put their arm in this area.

Risk of dragging and drawing in
