CASE STUDY

PHILIP MORANT SCHOOL AND COLLEGE

Type of Gate: Single leaf pedestrian gate. Constructed of box section steel and solid bar. Automation is by a rotational 24 volt motor and arm. Old manual gate that has been upgraded to automatic.

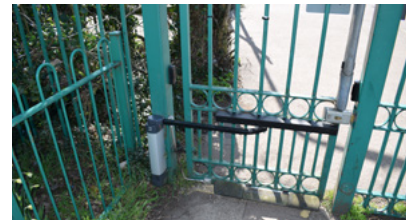
Risk of impact and crushing

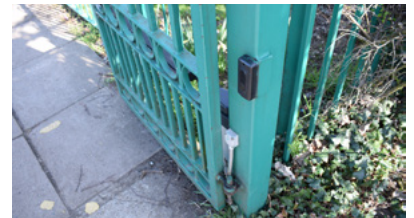
Risk of drawing in and crushing

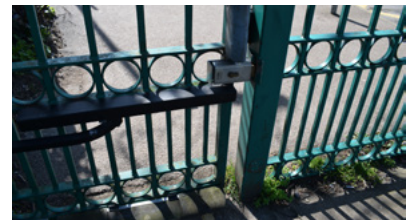
Risk of impact, crushing and drawing in

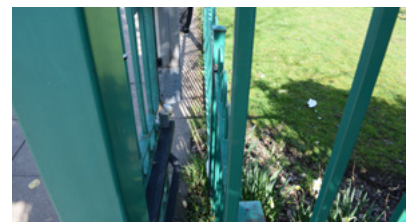
Risk of shearing

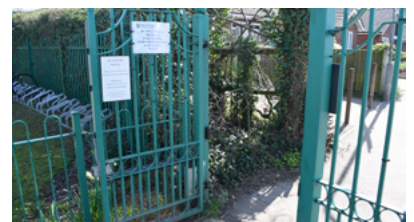
Risk of impact and crushing

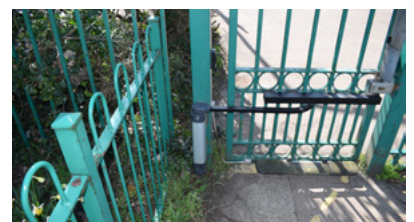
Risk of crushing
