# CASE STUDY

## TEMPSFORD COURT

**Setting:** Multi occupancy flats

**Type of Gate:** Single leaf tracked slider constructed of box section steel and railing powered by a 24 volt operator.

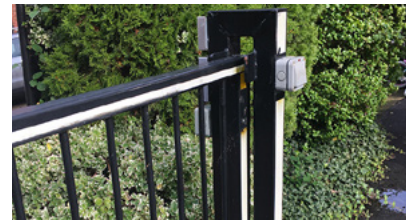
1. Risk of impact and crushing. No physical stop in the closed position. Potentially the gate could move past the fully closed position if the motor lost its position or the gate was moved in manual release.

Risk of impact and crushing

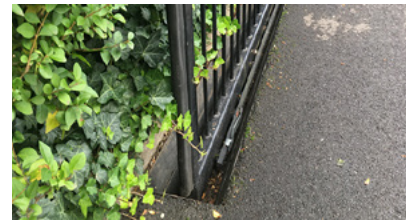
2. Risk of dragging and drawing in. No protection to gate leaf as it runs in the gully. Motor drive is also exposed. Potential access available from the outside of site between the hedge and gate. All these risks could be easily mitigated if the run back area were to be fenced off.

Risk of dragging and drawing in

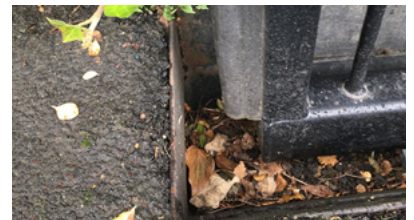
3. Risk of impact and crushing. Safety edge fitted to the rear of the gate leaf 120mm from bottom. This leaves an area unprotected by the edge. NOTE the requirement for this edge will be negated by the fitting of the cage as mentioned above.

Risk of impact and crushing

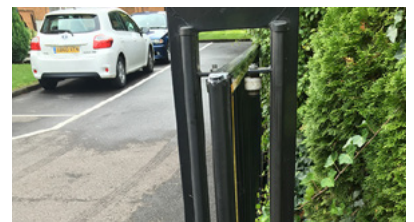
4. Risk of impact and crushing. Safety edges revert the gate when activated irrespective of gate direction. This could trap someone against the close portal if they touched the safety edge on the gate as it was opening. The edges should be wired to only work only in their desired direction.

Risk of impact and crushing

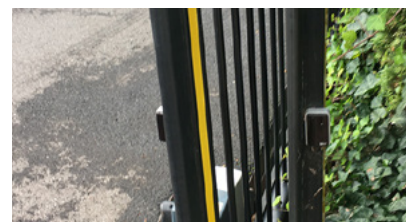
5. Risk of dragging and drawing in. Photocells do not stop the gate from starting to open should the photocell beam be obstructed. A person could place a limb through the gate and be dragged as the gate opens even if the photocells were interrupted.

Risk of dragging and drawing in

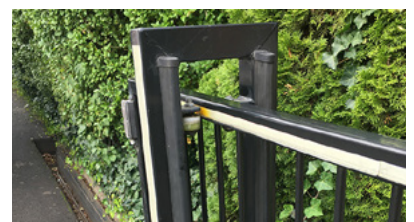
6. Risk of dragging and drawing in. Gap above the gate leaf in the hang portal is very large (100mm). Someone could get dragged into a dangerous position should they put their arm in this area.

Risk of dragging and drawing in
