## CASE STUDY

# AUTOMATIC GATE AT PRIMARY SCHOOL STAFF CAR PARK

**Setting:** Commercial (Education establishment)

**Type of Gate:** Double leaf swing gates constructed of steel box section and tube. Automated with 24-volt ram motors fitted at high level.

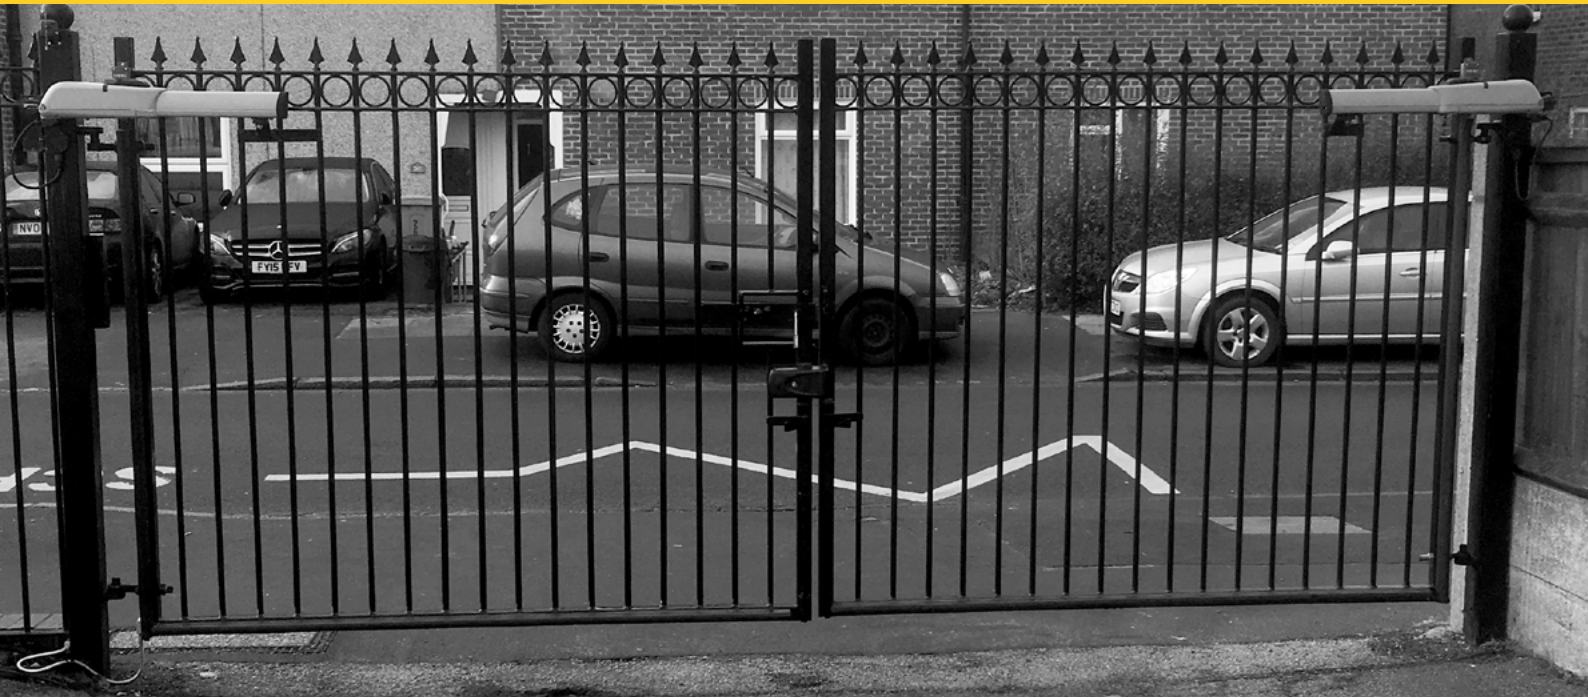
1. Risk of impact, trapping and crushing. Safety edges were only fitted horizontally to the bottom of the gate leaves on the inside of site. When tested, these edges only stopped the gates but did not revert. This represented a potential hazard since there was potential for a person to be pinned and trapped against the fence.

2. Risk of impact and crushing. No safety edges were fitted on the outside of the leaves horizontally or vertically to cover the reducing gap between the gates as they close.

3. Risk of impact and crushing. Only two hinges per leaf were fitted, with the top hinges inverted. In the event of one hinge failing, the leaves could easily fall. The weight of the leaves is supported only by the bottom hinges as the top ones are inverted, resulting in an even greater possibility of a gate failure.

5. Risk of impact and crushing. No inside photocells were fitted to cover the arc of the gates.

**Action taken:** All Gate Safe's comments were taken on board and subsequently, the recommended works for upgrading the system were put out to tender.
