CASE STUDY

SLIDING GATE AT MULTI OCCUPANCY FLATS

Setting: Multi occupancy flats

Type of Gate: Single leaf tracked slider constructed of box section steel and railing powered by a 24 volt operator.

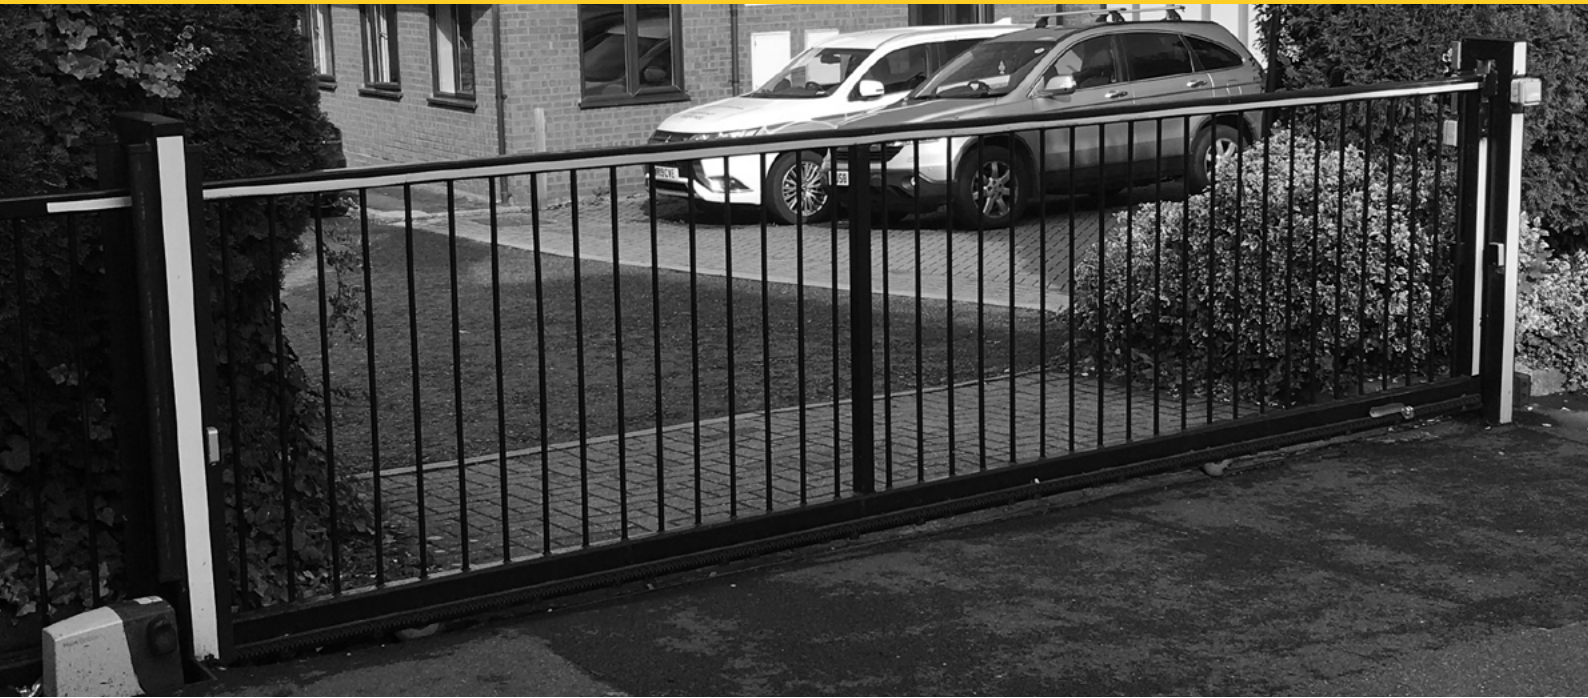
1. Risk of impact and crushing. No physical stop in the closed position. Potentially the gate could move past the fully closed position if the motor lost its position or the gate was moved in manual release.

2. Risk of dragging and drawing in. No protection to gate leaf as it runs in the gully. Motor drive is also exposed. Potential access available from the outside of site between the hedge and gate. All these risks could be easily mitigated if the run back area were to be fenced off.

3. Risk of impact and crushing. Safety edge fitted to the rear of the gate leaf 120mm from bottom. This leaves an area unprotected by the edge. NOTE the requirement for this edge will be negated by the fitting of the cage as mentioned above.
